STATE OF COLORADO

COLORADO DEPARTMENT OF HEALTH

July 19, 1988

Re: Annual Inspection of Wastewater Treatment Facilities for Terry Tunnel,
Mayflower Mill and American Tunnel, respectively, CPDES Permit No.
CO-0036056, CO-0000426, and CO-0027529, San Juan County

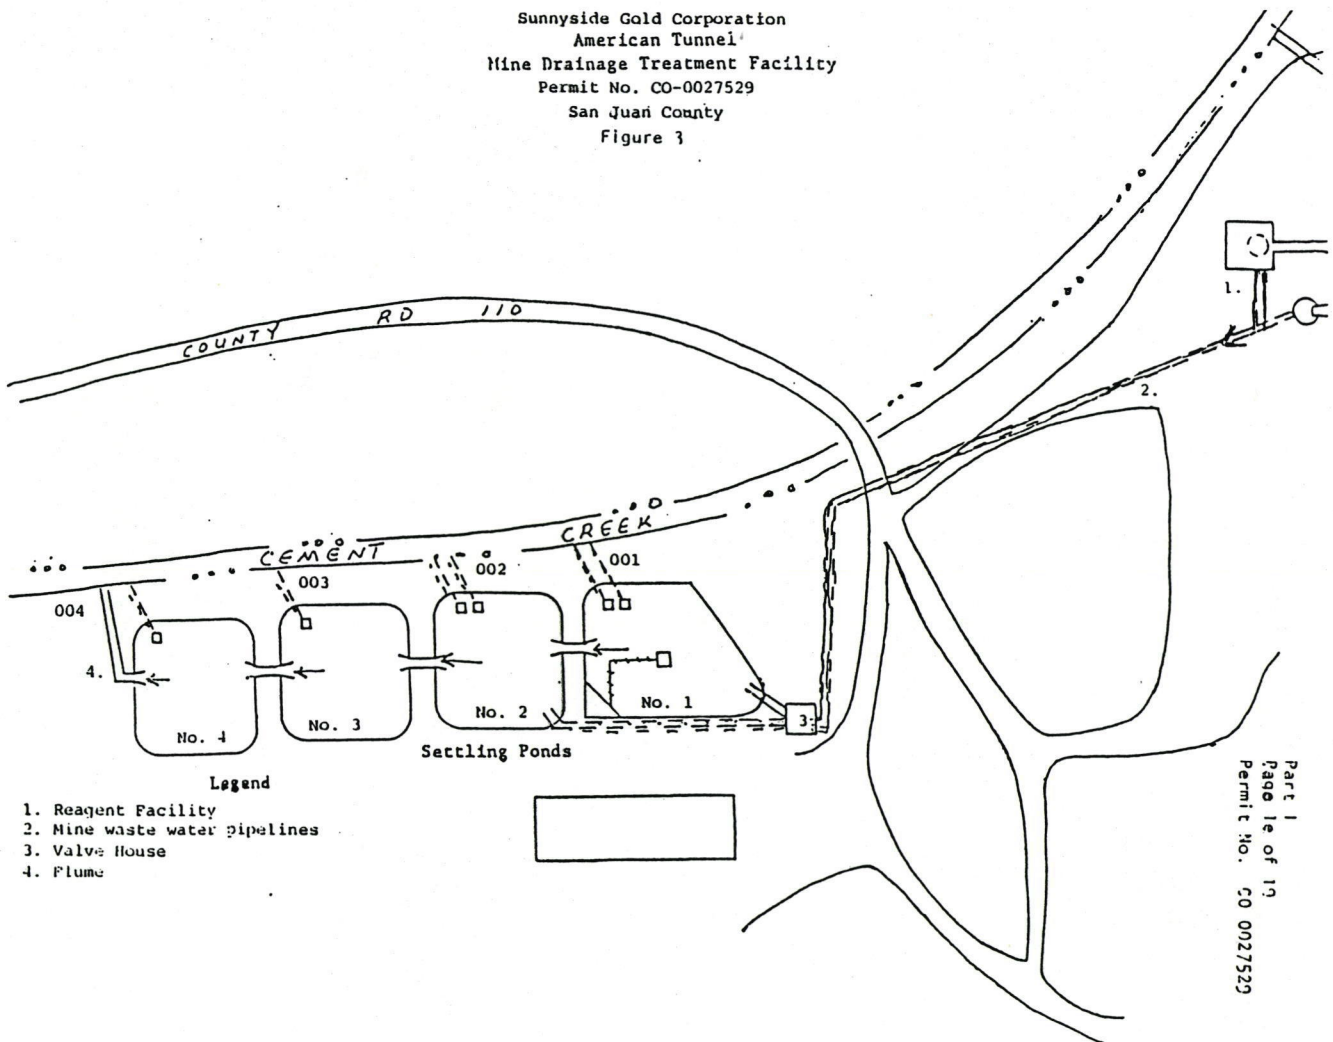
Sunnyside Gold Corporation
American Tunnel
Mine Drainage Treatment Facility
Permit No. CO-0027529
San Juan County
Figure 3

Treatment Facility Evaluation Treatment of drainage water by pH adjustment (lime), flocculation, precipitation, settling in 4 ponds in series. They are presently treating 3/4 of the water and blending with remaining 1/4. The facility has frequent power failures which upsets the treatment process. Additionally, the ponds appear to be full of sludge and are short circuiting.

Facility Deficiencies The treatment facility needs a back-up power supply, the ponds are full of sludge and are short circuiting.

Facility Evaluation vs. Permit Due to the high frequency of power failures, I recommend that they install a back-up power supply. Additionally, I think improvements should be made to the ponds to prevent short circuiting. Regarding the water used for showering, signs (NON-POTABLE WATER) should be posted at taps for the workers' safety.

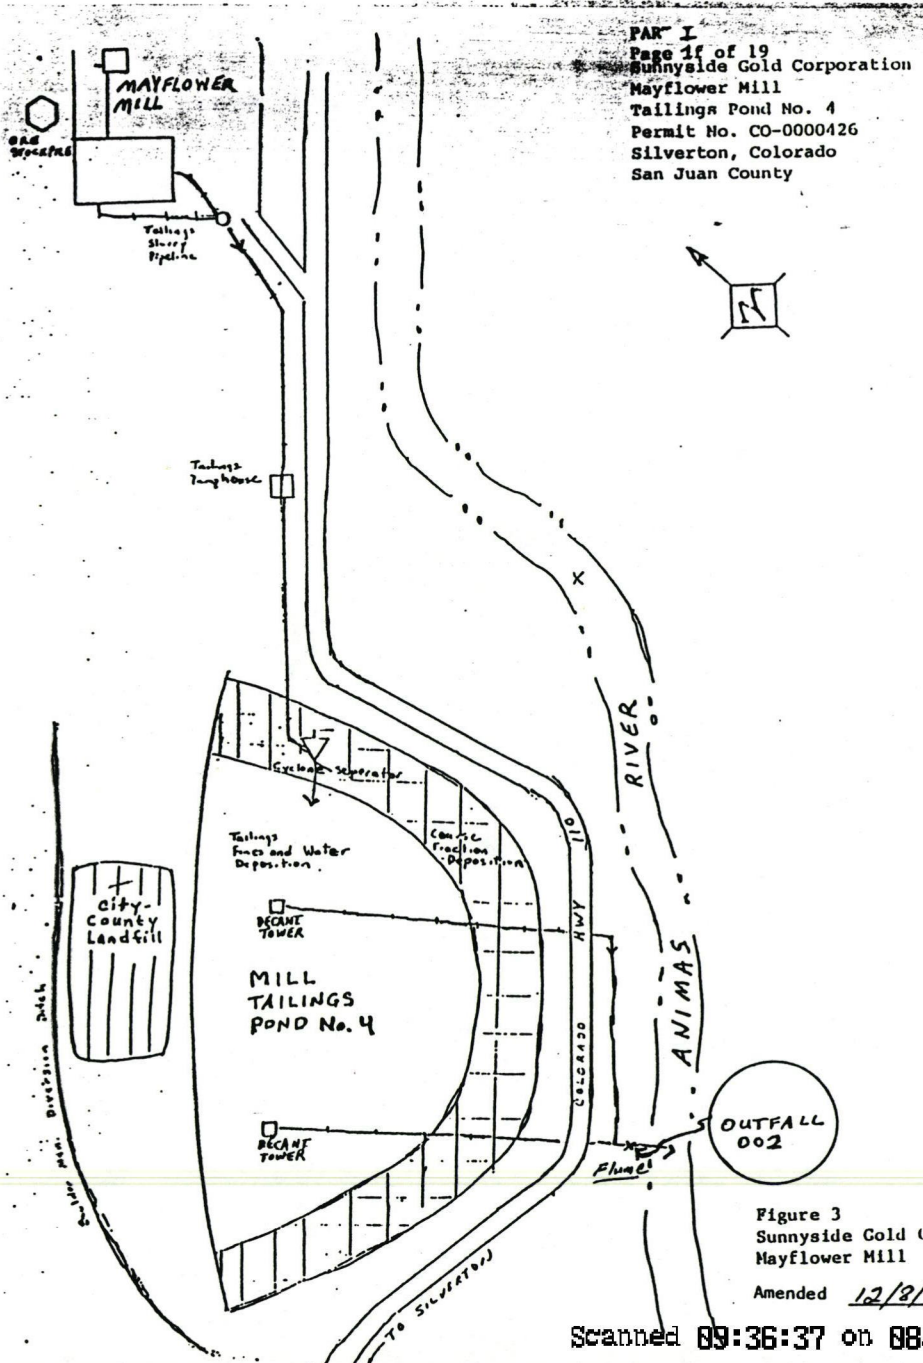
SKETCH

Facility Evaluation vs. Permit Effluent flow measuring device does not measure
to an accuracy of 10% (the trapizoidal flume leaks and does not have a staff
gage).

Facility Deficiencies Needs a more accurate flow measuring device, and improve chemical storage.

The trapezoidal flume leaks and does not have a staff gauge. This flow measuring device does not measure to an accuracy of 10% as required by your permit and must be repaired.

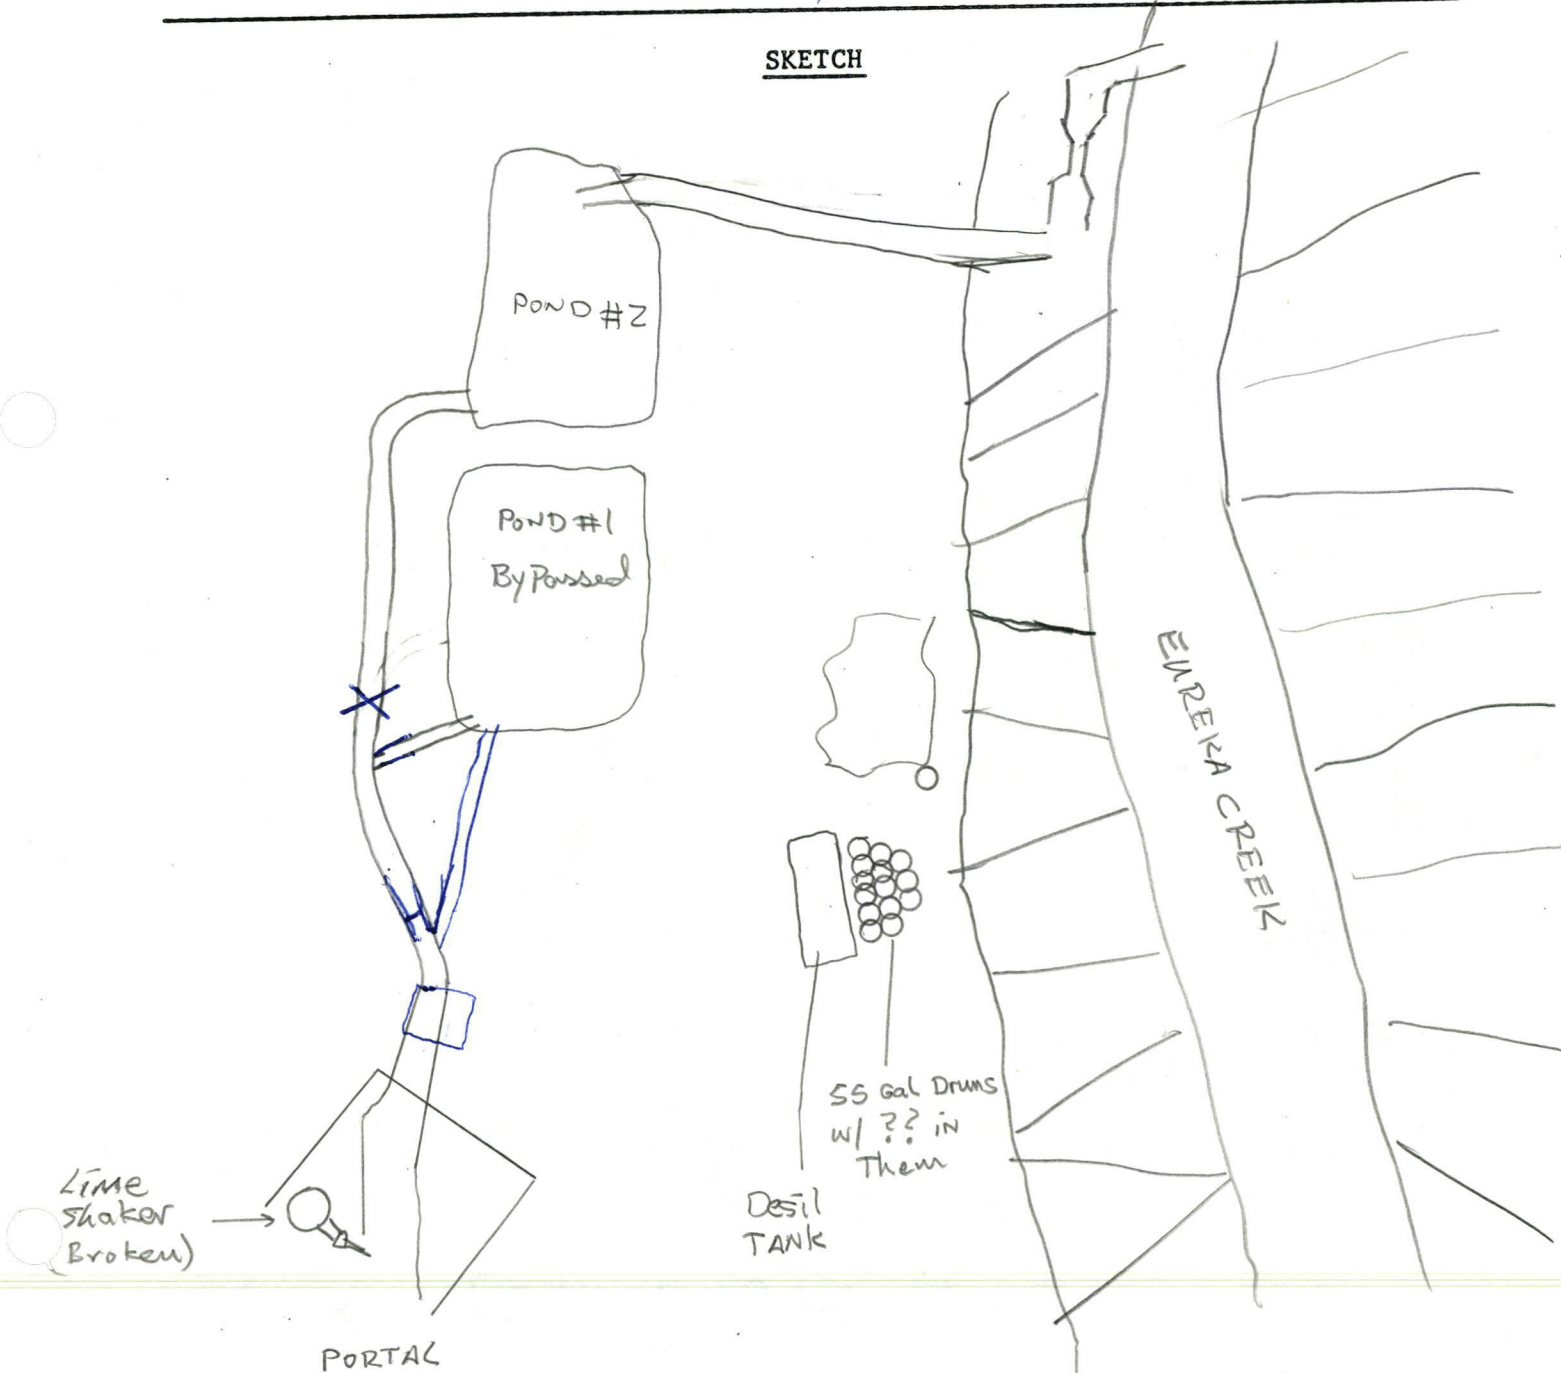
SKETCH

PH Process Control new plant issue
Treatment Facility Evaluation Facility at present is not adequate. Lime feeder is broken (they are hand feeding, but very intermittently), the first settling pond is bypassed due to leakage, parshall flume has been relocated w/o a permit amendment and leaks and is not level, second pond is suspected to leak. They plan on repairing the ponds this summer, Mined land reclamation told them to move the flume, they ordere parts for the lime feeder, however their backup feeder was also broken.

Facility Deficiencies Chemical feed system is inadequate (broken) and there is no back-up equipment. System does not operate in the winter due to access problems.
Ponds need to be lined and also cleaned, with the sludge disposed of in a proper manner.
The flow measuring device needs repair. Fuels and other chemicals (???) need to be labeled and contained in a better manner.

Groundwater Impact Potential Very high potential of contamination of subsurface water from the leaking ponds, and fuels and chemicals stored on the ground.

→ Facility Evaluation vs. Permit ~~Need to amend your~~ permit to show relocation of parshall flume, flow measuring device not accurate to 10%, not using pond #1, not chemically treating water.
